**U.S.-India Joint
Center for Building Energy Research and Development
(CBERD)**

Post occupancy analysis

Centre for Scientific Research, Auroville

November 2017

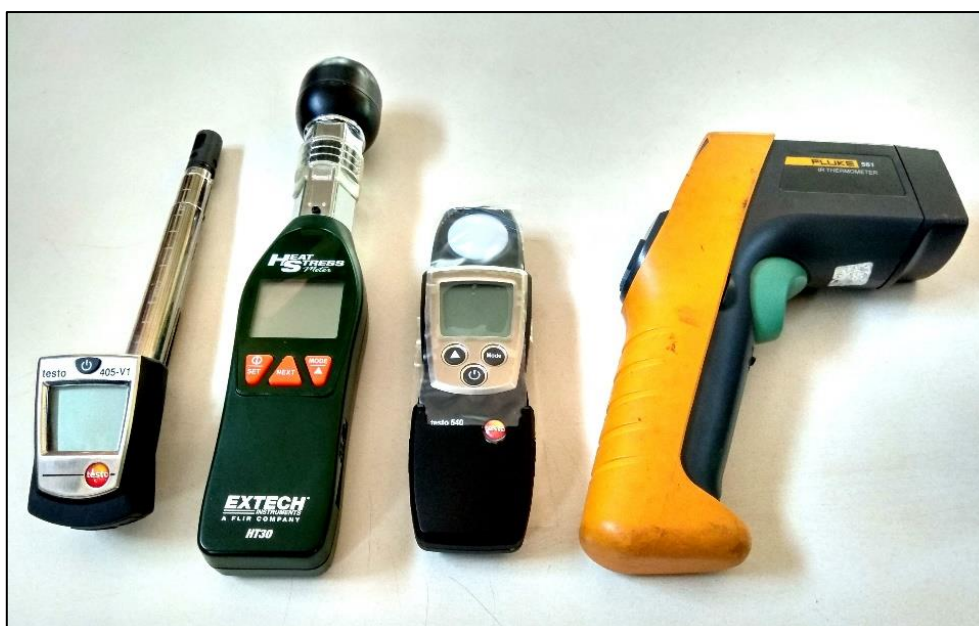
Figure 12 Handheld measurement instruments: Testo 405-V1 Anemometer, Extech HT30 Heat Stress Meter, Testo 540 Lux Meter, and Fluke 561 – IR Thermometer respectively

Instantaneous measurements of air and globe temperature and relative humidity were taken using the Extech HT30 Heat Stress meter (Figure 12). Black globe temperature monitored the effect of direct solar radiation on an exposed surface. Its globe temperature measurement range was 0 to 80°C ($\pm 2^\circ\text{C}$ accuracy), air temperature measurement range was 0 to 50°C ($\pm 1^\circ\text{C}$) and relative humidity measurement range was 0 to 100% ($\pm 3\%$ at 25°C, 10 to 95% RH) Extech (n.d). The indoor instantaneous lux measurement was carried out using Testo 540 Lux Meter (Figure 12). It had a measuring range of 0 to 99999 Lux with an accuracy of ± 3 lux and a resolution of 1 Lux. The measuring rate of the device was 0.5 seconds – Testo (n.d). The instantaneous surface temperature was measured using Fluke 561 IR Thermometer, which uses a single point laser sighting. The temperature measurement range was -40 to 550°C with a resolution of 0.1°C. It employs a K-type thermocouple for precise thermal measurement up to $\pm 1\%$ of the reading at the ambient temperature of 23°C – Fluke (n.d.).

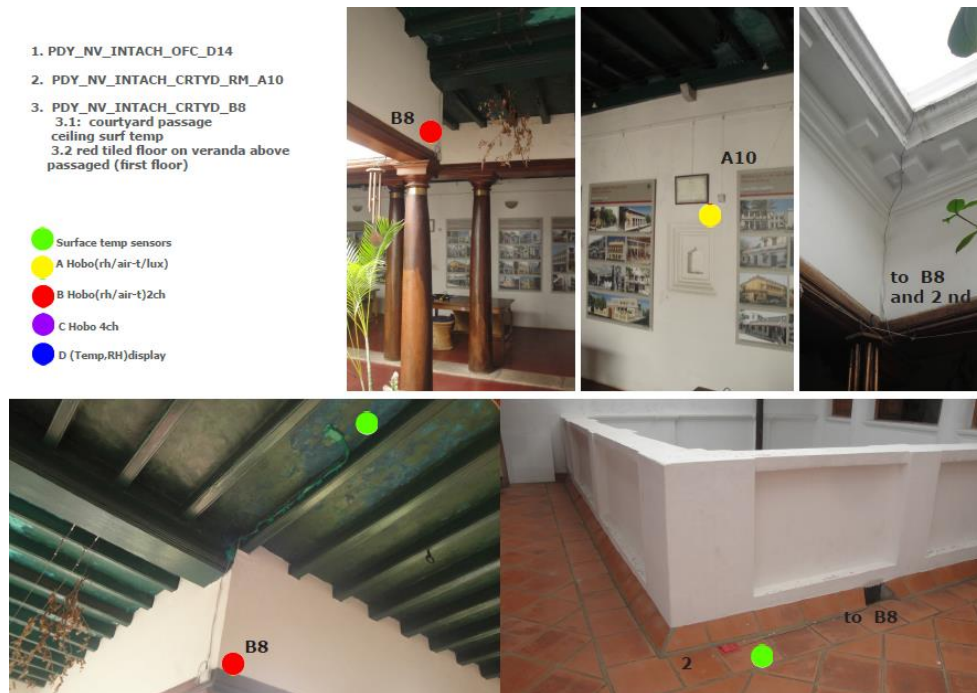
Figure 28 Placement of loggers in INTACH office – site photos

Figures 27 and 28 show the locations for logger placement in the building with the on-site photographs and the building plan.

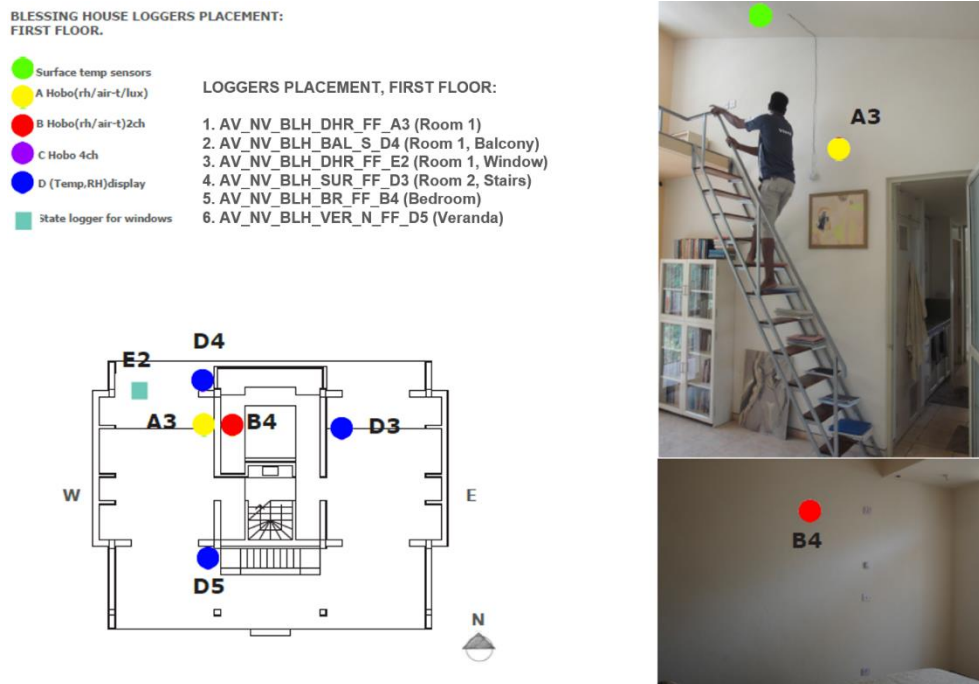
Figure 30 Placement of loggers on the first floor

Figure 30 shows the placement of loggers on the first floor. Loggers A3, B4, D3, D4, and D5 measure the parameters for the first floor, while E2 logs the open/close state of the balcony window. Figure 31 measures the parameters on the mezzanine using logger C4.

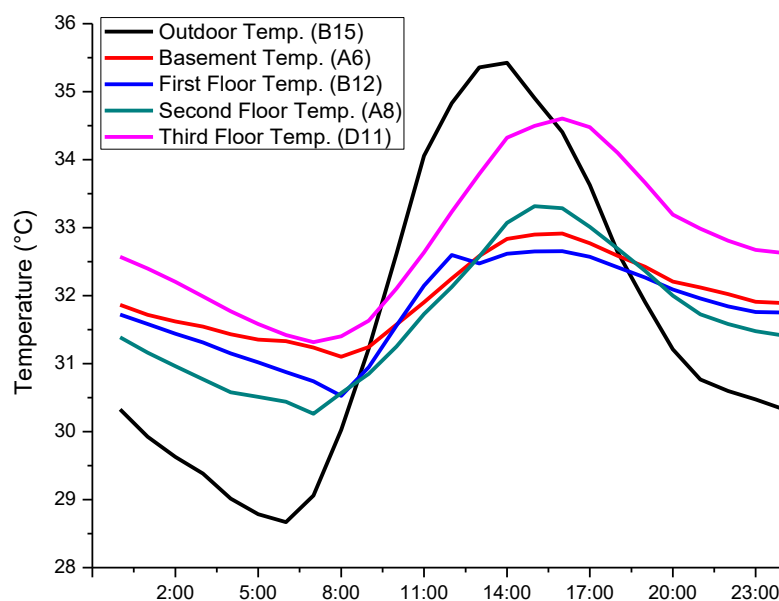
Figure 48 Variation of Hourly Avg. Temp. across floors, June 2014

Figure 48 shows the hourly averaged values of air temperature and relative humidity for the month of June across all the floors of Golconde. The outdoor temperature varies from 28.5 to 35.5 degrees between the dawn and the noon respectively. Temperatures on all the floors follow the same curve as the outdoor temperature but with a time-lag of 2 hours between their peak values, due to the thermal mass of the building fabric. The coolest portion of the building during the hottest hours (11:00 – 17:00) of the day was the first floor. The basement, first and second floor temperature profiles were quite similar to one another due to similar thermal masses above and below them. The third floor was warmer than the rest of the floors by over 1 degree, however, it still was more moderated than the outdoors by over 2 degrees. The topmost floor of any building was most likely to have the hottest temperatures due to the vicinity to the rooftop – solar radiation heated up the rooftop and the heat was conducted through the ceiling to the topmost floor, wherein, indoor convection currents distributed the heat to the entire room, maintaining the thermal equilibrium.

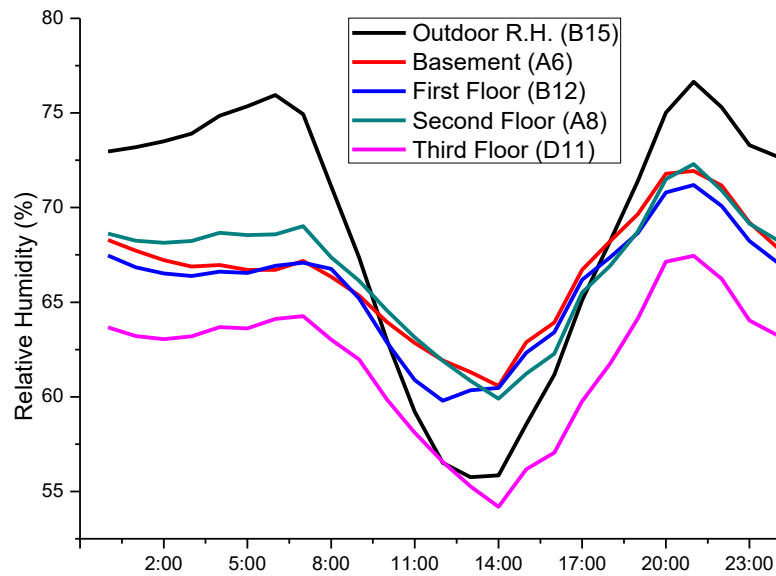
Figure 49 Variation of Hourly Avg. R.H. across floors, June 2014

undulating R.H. curve below – the colder hours of the day experienced a higher R.H. level than the warmer hours, also, the third floor is the least humid floor as it had the highest temperature in comparison to the other floors.

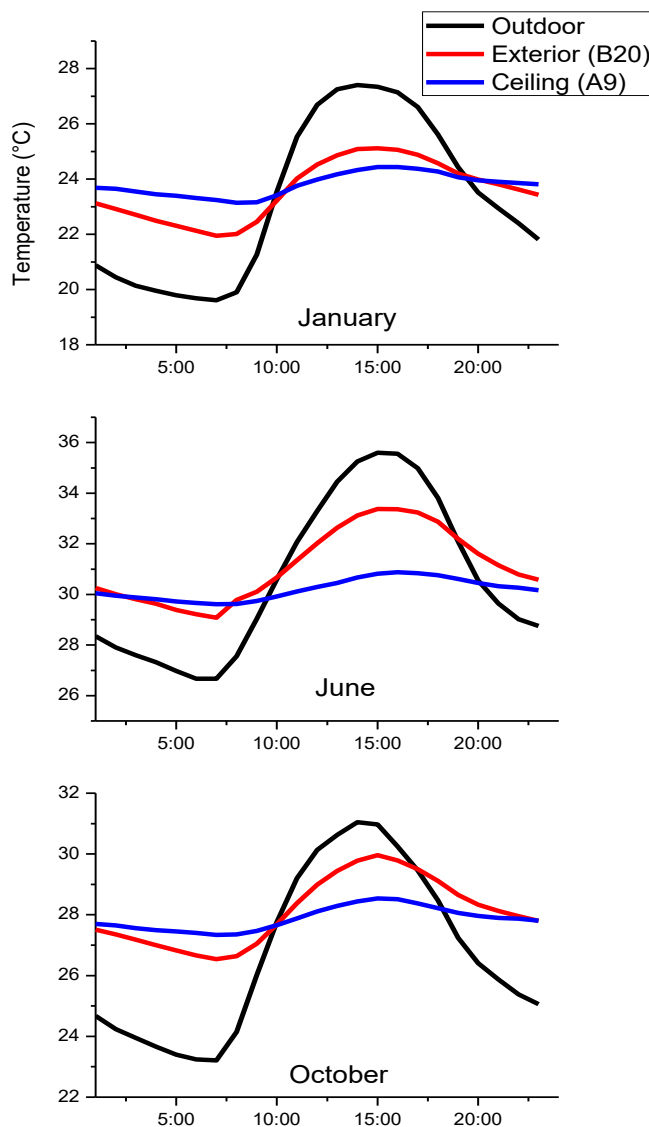
Figure 95 Variation of hourly averaged surface temperatures across the rooftop for three months/seasons, 2014
